GEOTECHNICAL AND CRITICAL AREAS REPORT

LUDWIG RESIDENCE

9921 SOUTHEAST 16TH STREET

Project No. 22-219
October, 2022

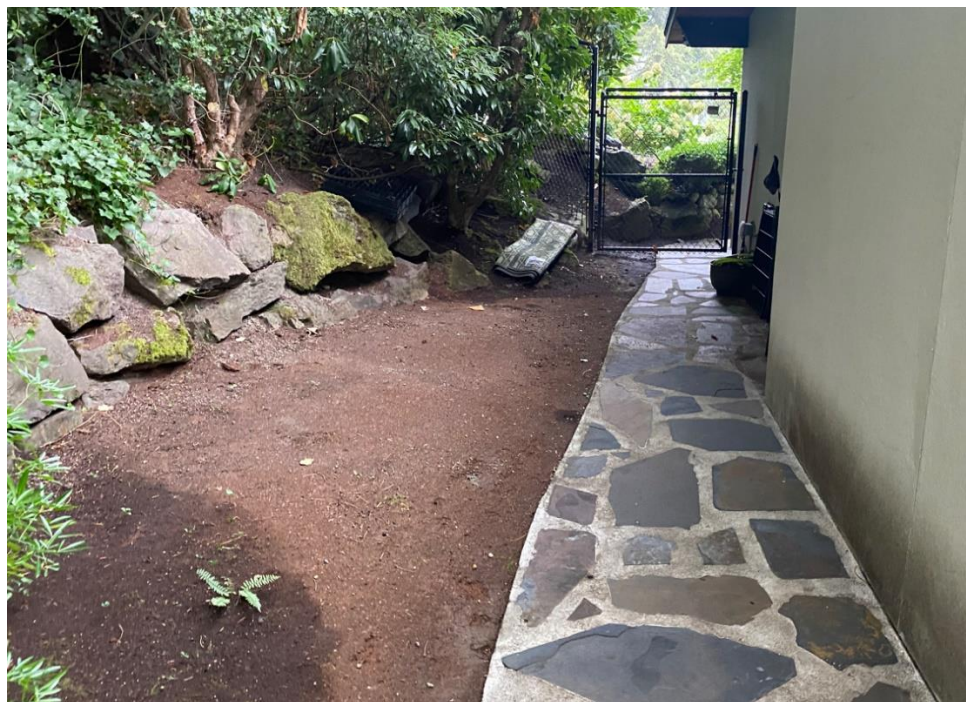
Plate 1. View of the existing conditions on the south side of the house where the proposed addition is planned, looking west.

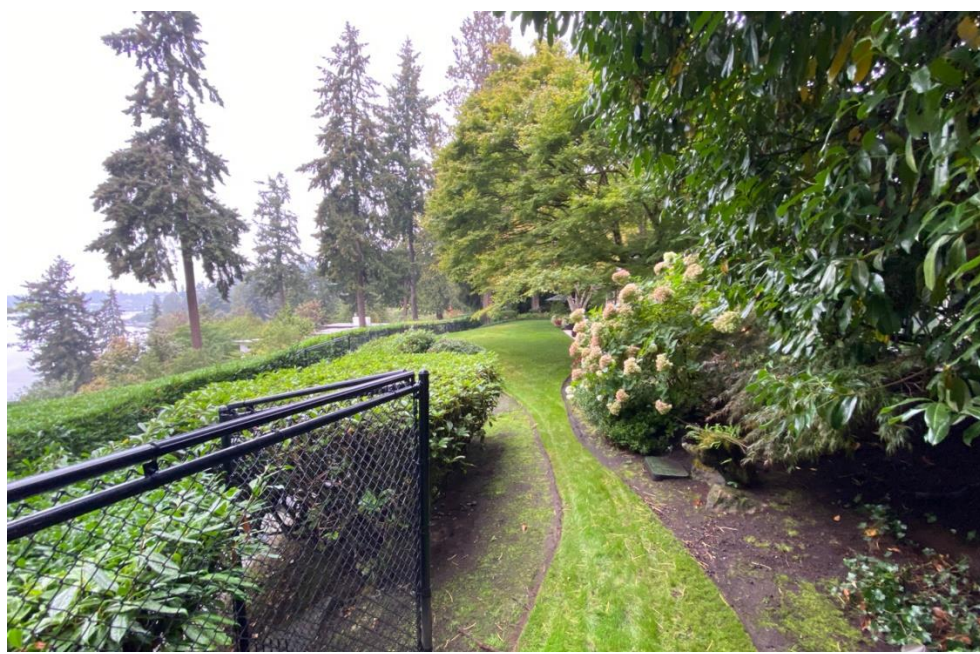
Plate 2. View of the west side of the property near the top of the west-facing slope mapped as steep slope critical area, looking north.

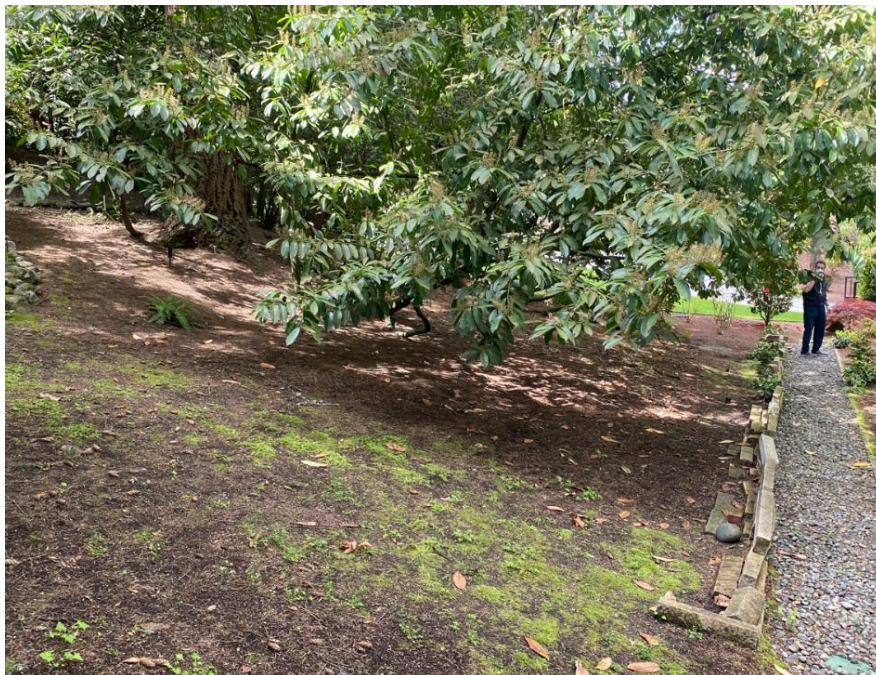
Plate 3. North-facing slope on the east side of the property at the location of the proposed detached carriage house, looking west.

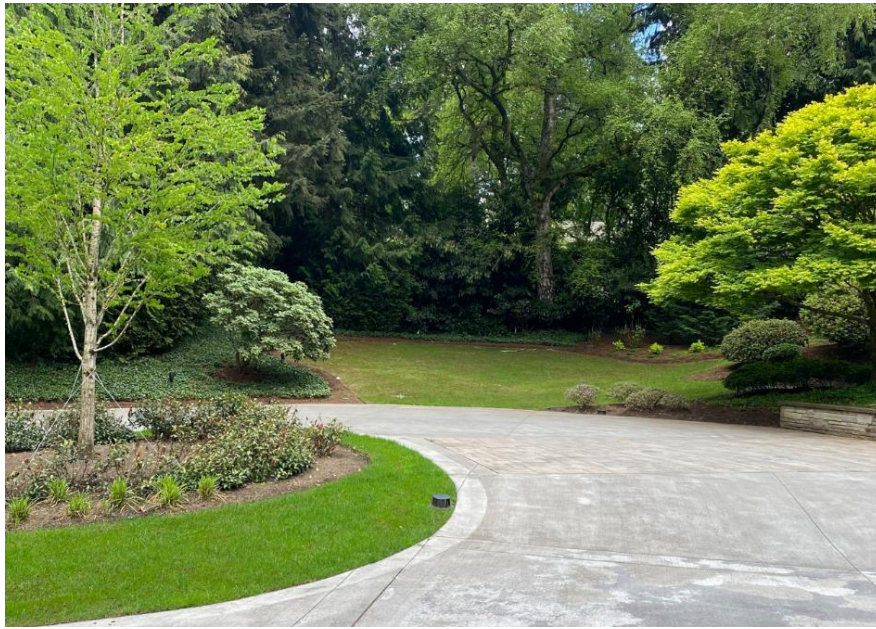
Plate 4. Existing lawn near the southeast corner of the existing house and south side of the roundabout driveway at the proposed sport court location, looking south.

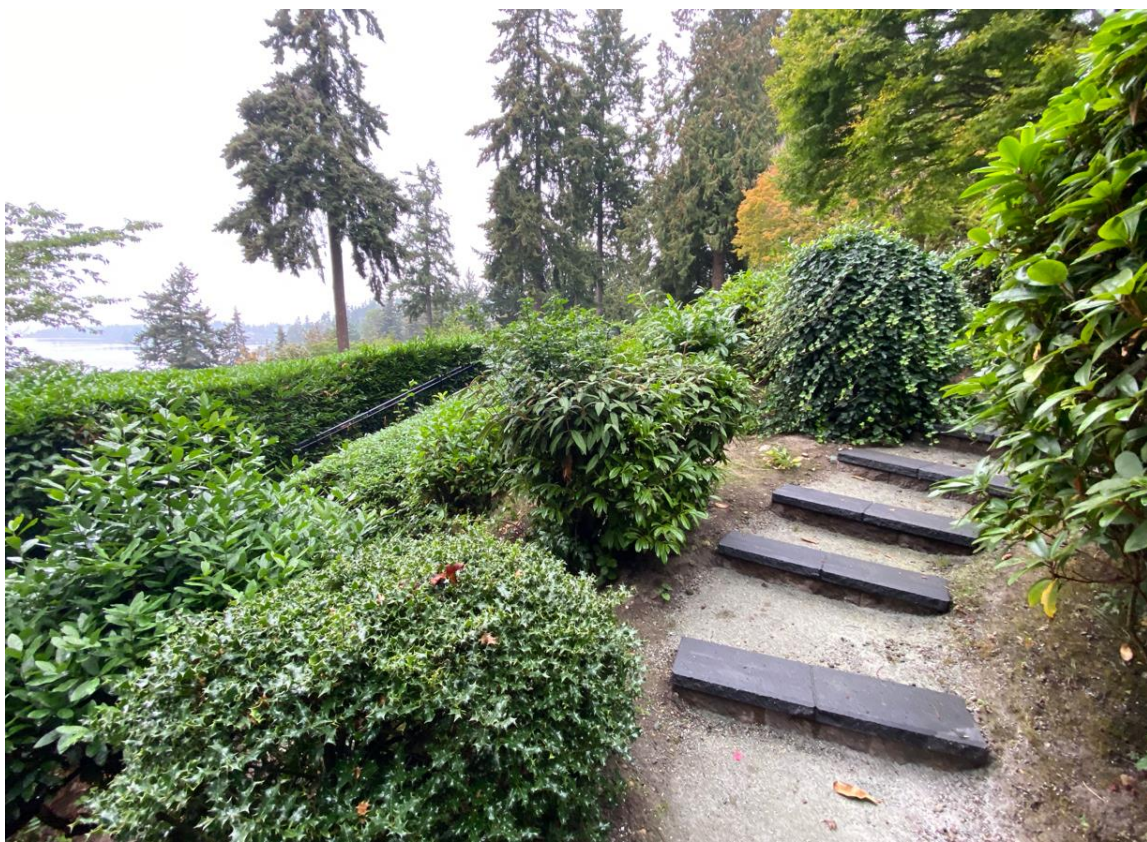
Plate 5. View of the existing conditions along the west slope, looking north.

During our site reconnaissance, we did not observe evidence of recent instability such as slide scarps, hummocky ground surface, or tension cracks around the existing house, along the south side of the house where the proposed addition is located, and in the west steep slope critical area. The area around the proposed addition on the south side of the existing house and up to 30 feet to the top of the mapped steep slope to the west is practically level with no signs of slope movement. The west slope appeared to be well landscaped with a variety of bushes and hedges, along with a gravel path with paver stairs (see Plate 5 below). The ground surface around slope vegetation appeared to be completely covered with mulch and topsoil. We also did not observe signs of

erosion on the ground. We did not observe signs of leaning or creep in the vegetation or pathway. Existing trees on the site slopes also appear vertical with no obvious signs of creeping soil (see foreground of Plate 5).

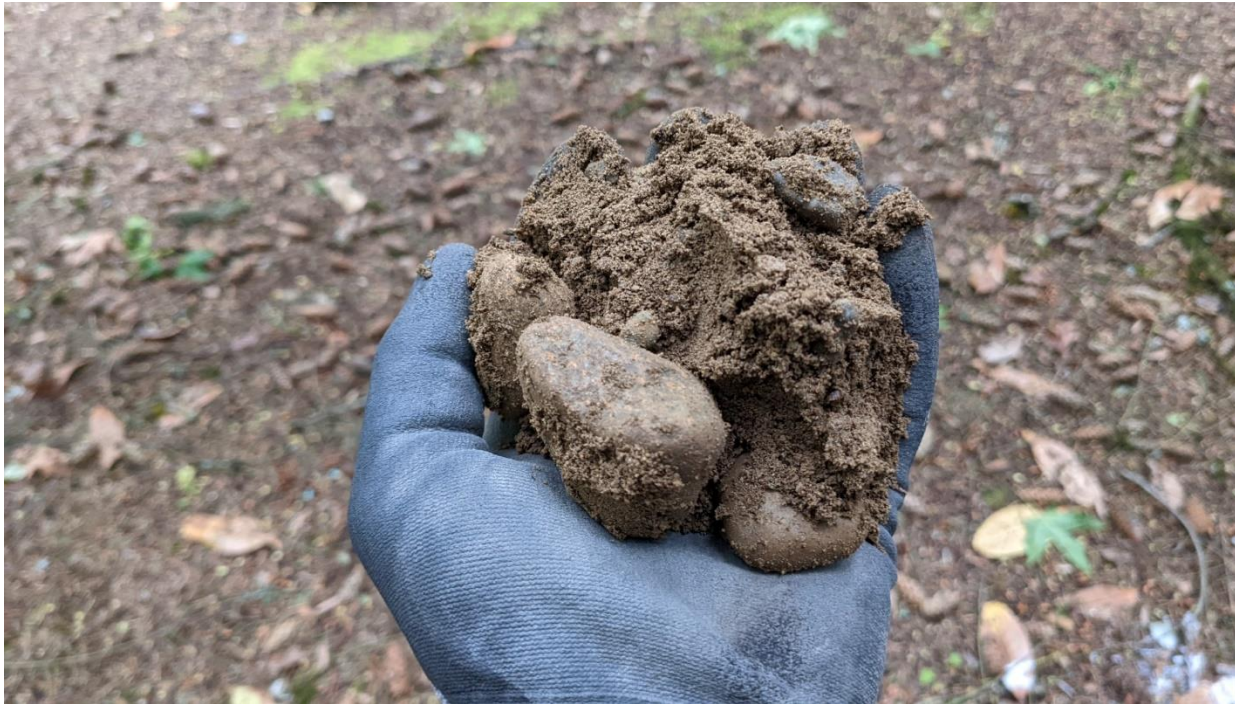
Hand Boring No. HB-1	
Location: 47.596508, -122.2-7992 (WGS84)	
Approximate ground surface elevation: 100 feet (NAVD88)	
<u>Depth (ft)</u>	<u>Material Description</u>
0 – 1/3	Topsoil and forest duff: 4 inches thick
1/3 – 2	Medium dense to dense, light brown, silty SAND with gravel, moist [Weathered Older Sand Deposits - Qos], occasional roots
2 – 2 1/2	Dense to very dense, light brown, slightly silty SAND with gravel, moist [Older Sand Deposits - Qos] - Refusal at approximately 2 1/2 feet

Image of soils encountered approximately 2 feet below the existing ground surface. Groundwater seepage was not observed during excavation.	
Logged by: J. Manke

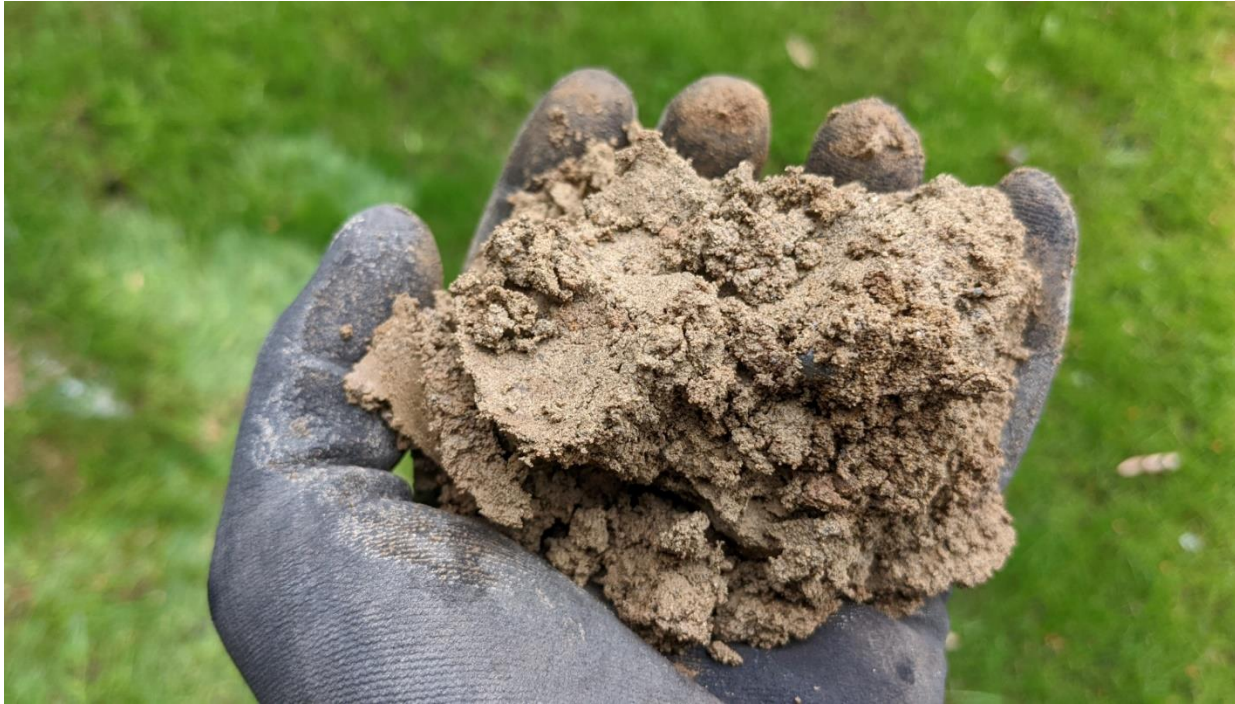
Hand Boring No. HB-2	
Location: 47.596258, -122.208422 (WGS84)	
Approximate ground surface elevation: 108 feet (NAVD88) 47.596483, -122.207925	
<u>Depth (ft)</u>	<u>Material Description</u>
0 – ¼	Grass and topsoil: 3 inches thick
¼ – 3½	Medium dense, light brown, silty SAND with trace gravel, moist [Weathered Older Sand Deposits - Qos] , occasional roots
3½ – 4	Dense to very dense, light brown, slightly silty SAND with gravel, moist [Older Sand Deposits - Qos] - Refusal at approximately 4 feet

Image of soils encountered approximately 2 feet below the existing ground surface. Groundwater was not encountered at the time of excavation.

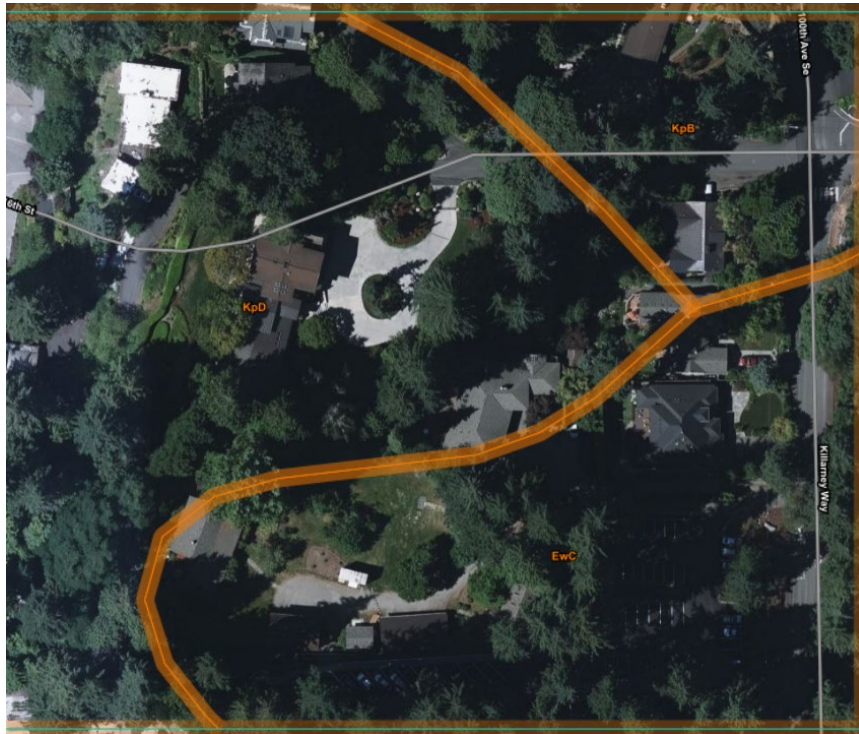
Figure 3. The soil profile on-site (Web Soil Survey).

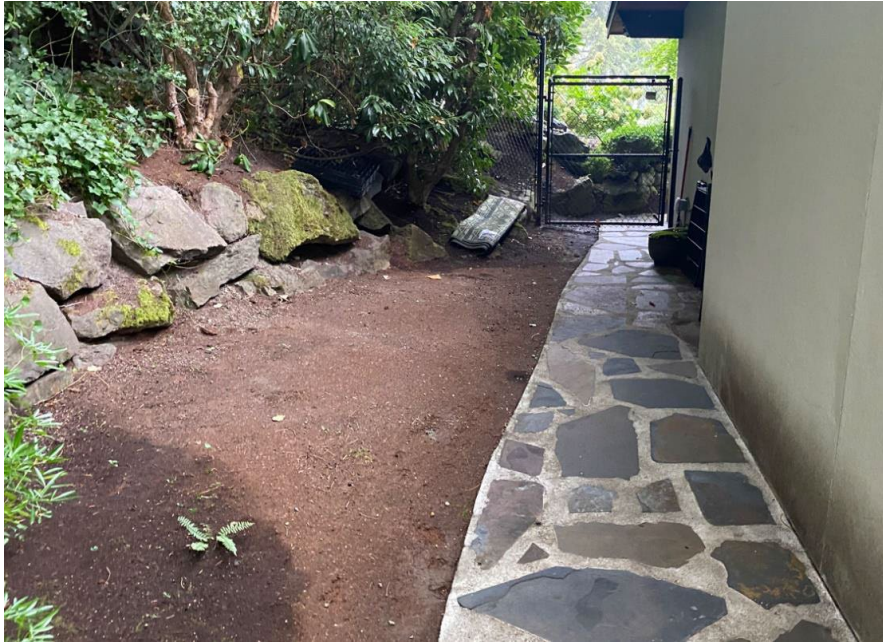
Figure 7. View of the existing conditions on the south side of the house where the proposed addition is planned, facing west.

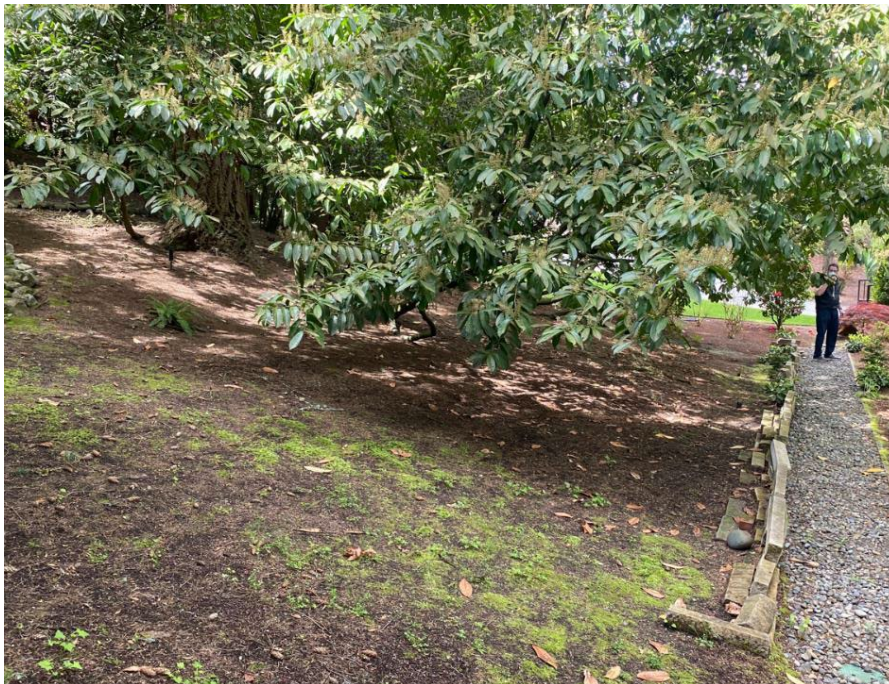
Figure 8. North-facing slope on the east side of the property at the location of the proposed Guest Cottage, facing west.

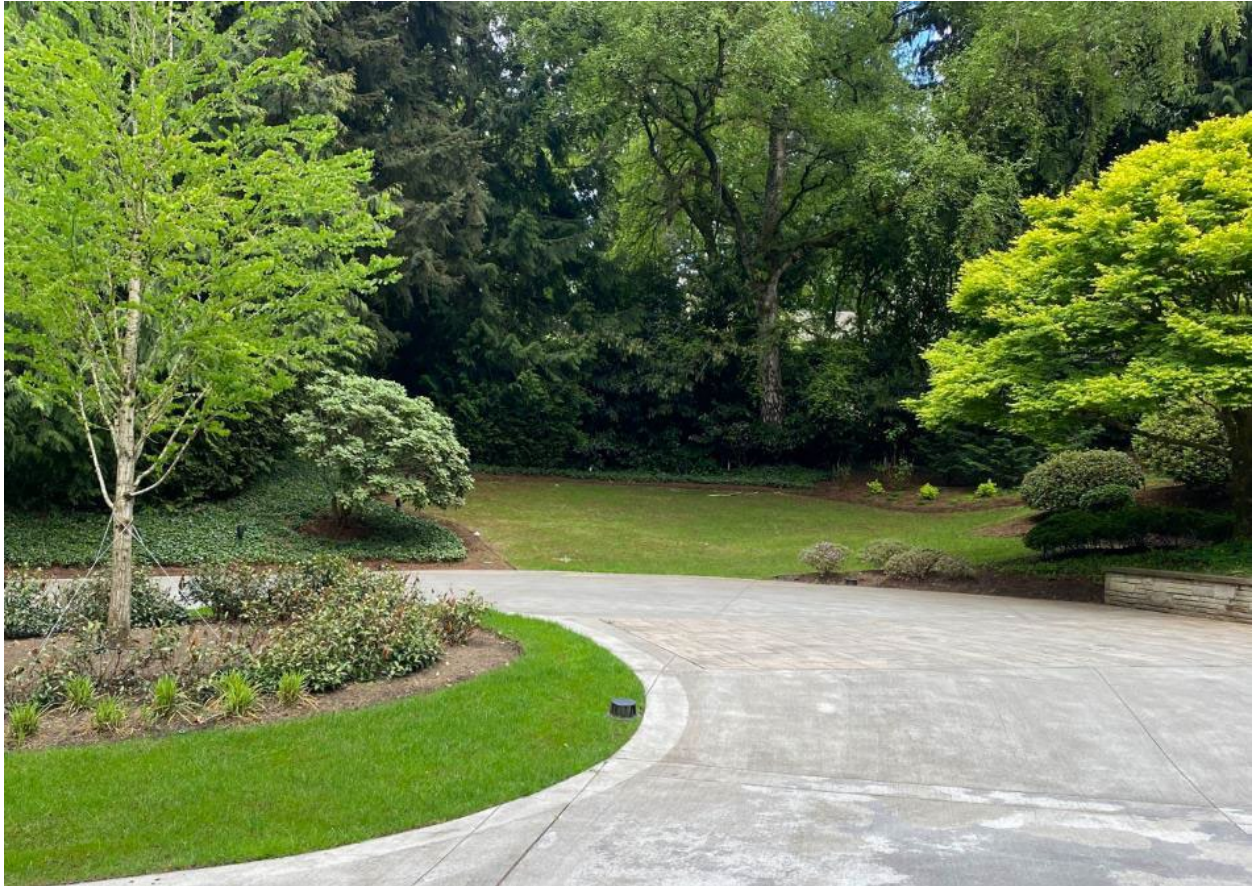
Figure 9. Existing lawn area near the southeast corner of the existing house and south side of the roundabout driveway at the proposed sport court location, facing south.
